# tussen Duin & Dijk

Nature in Noord-Holland. Volume 17 3 ● 2018

# measure the biodiversity of banks and shores

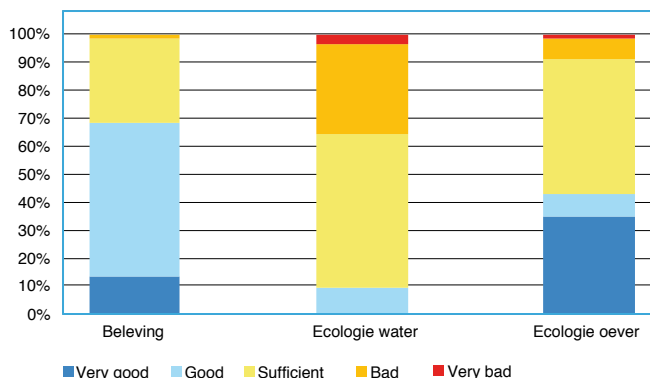
● Figure 2. 2016 Results for amenity value, bank ecology and water ecology.

The banks that were monitored tend to score well when it comes to amenity value (figure 2). Only 2%, which was one bank, scored badly.

Nearly half of the banks achieved a satisfactory score and 9% received a lower score (figure 2). HHNK can use this data to determine whether the management could be improved. The *Stadswatertoets* also assessed the water ecology. The assigned value for the water ecology is determined by the water clarity, aquatic plants and the species present. A high degree of coverage by underwater plants increases the score. The presence of floating algal beds and other algae leads to a lower score. What also emerges from the *Stadswatertoets* is that water sites tend to score lower than the bank sites: no less than 36% scored poorly to very poorly and only 9% scored well (figure 2).
